# PHYSICAL NEEDS ASSESSMENT

## PRELIMINARY REPORT

**Lincoln-Sudbury Regional High School**

April 30, 2026

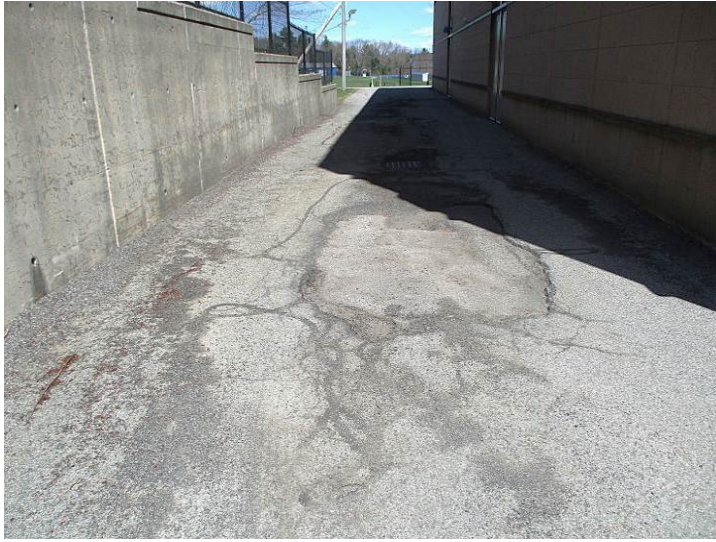
Significant asphalt deterioration observed at the east side of the C block will be addressed in the near term (per management)

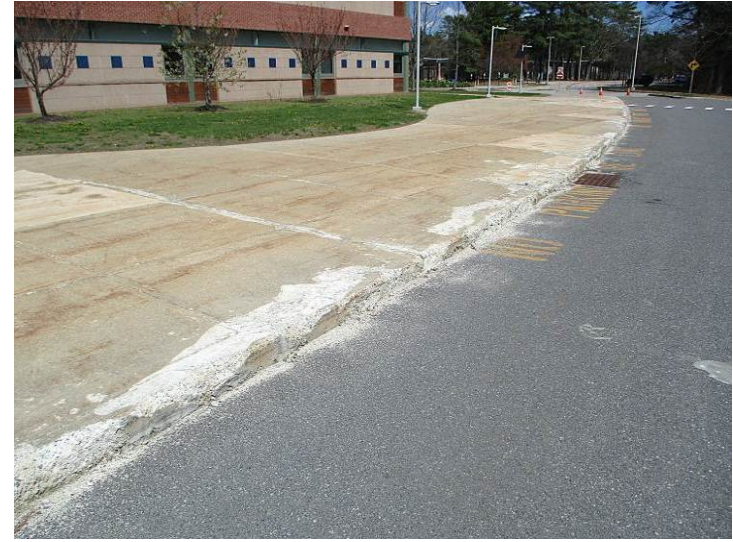
The significant salt/snow-melt related concrete flatwork deterioration at the front/main and auditorium entrance plaza will also be addressed in the near term.

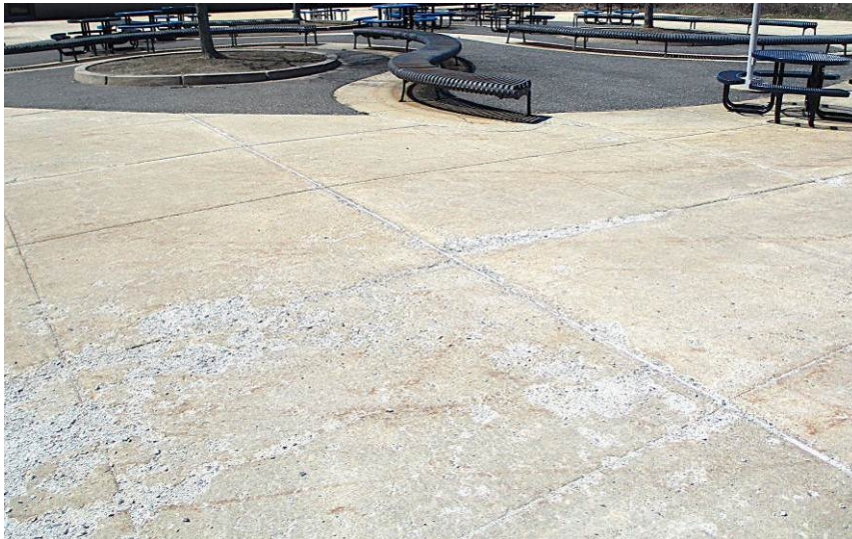
Similar concrete surface deterioration is developing at the cafeteria plaza.

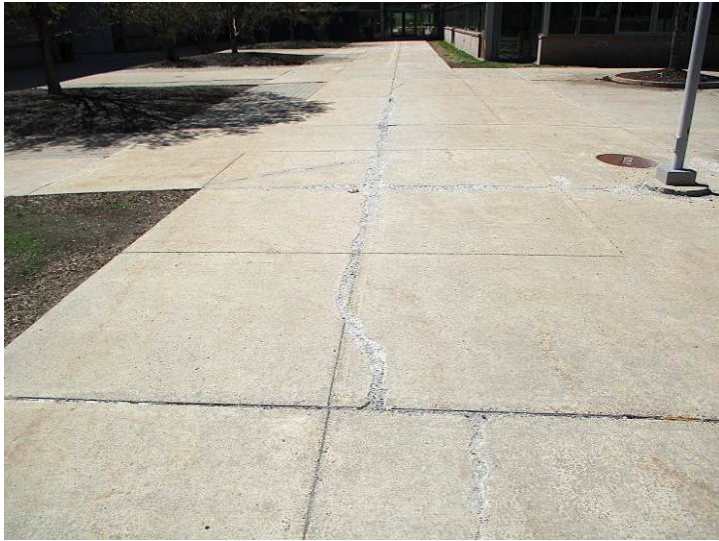
Similar concrete flatwork deterioration observed at the student entrance plaza (adjacent to the cafeteria plaza).

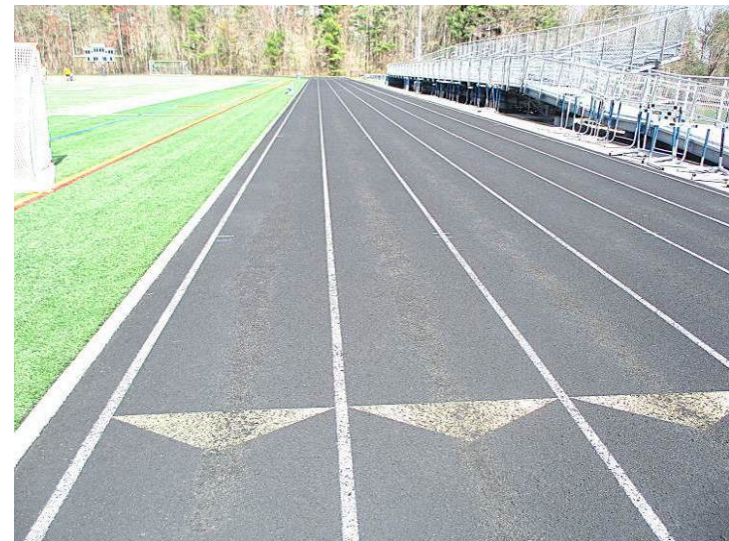
6. The Stadium features a rubberized 6-lane running track and football field D-area that was originally installed in 2007; and a subsequent structural spray resurfacing was completed in 2019. Visible cleat-related surface wear has developed since that time (particularly at the first 100 meters between the start line and first turn). Based on current age, observed conditions, and timing input from management, a full replacement of the track (base-course and surface) is shown in Year 4; and a subsequent spray resurfacing cycle is shown in Year 14, after ten years of use.

Visible cleat damage and surface wear will eventually necessitate a full replacement of the rubberized system.

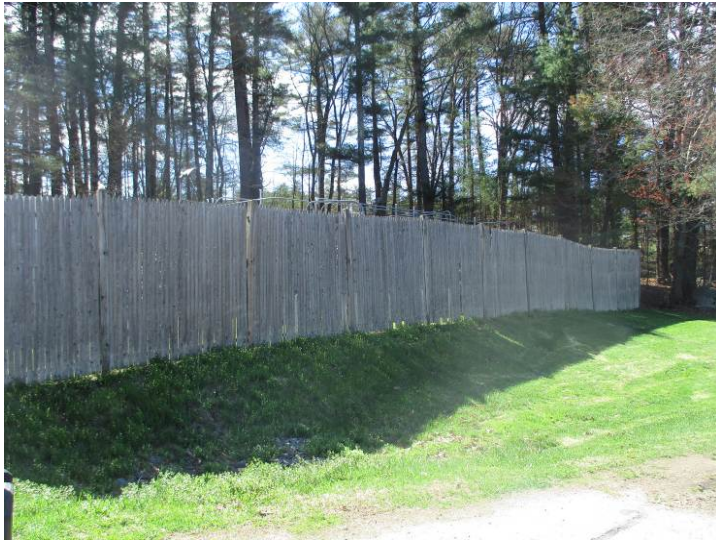
4. The wastewater treatment facility features wood-stockade perimeter fencing that is visibly older, ageing, weathered/rotting, and in need of near-term replacement. Although under the \$50,000 threshold, replacement costs are shown in Year 1, concurrent with the management-reported plan to fully overhaul/replace the wastewater treatment facility (discussed further below).

The visibly older, ageing, wood-stockade perimeter fencing at the wastewater treatment facility is in need of near-term replacement.

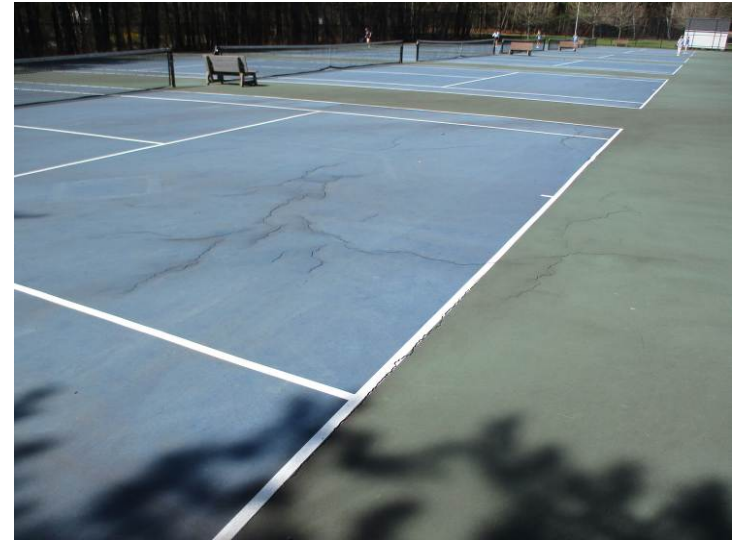
5. The asphalt/acrylic-surface tennis courts were repainted in 2021 but exhibit widespread non-repairable, age-related cracking. The partially-collapsed northeast-corner was raised and repaired but is visibly cracking and settling again. These issues are most likely related to the location of the courts, which appears to be at a low-point of the property where drainage water migrates and settles. Costs to fully rebuild/replace the courts are shown in Year 3, after twenty-five years of use. Future surface painting costs will be covered by the facility's operating budget (under \$50,000).

The asphalt/acrylic-surface tennis courts were repainted in 2021 but exhibit widespread age-related cracking.

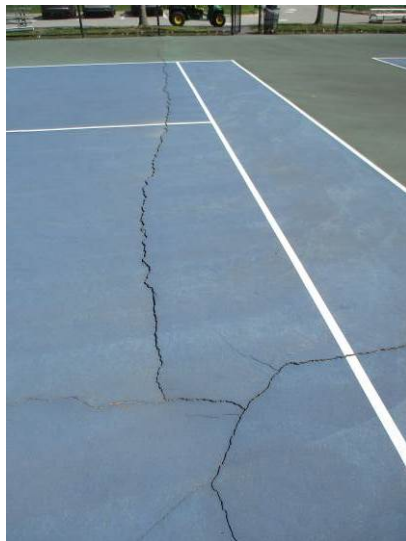
The cracking is extensive and non-repairable. A near-term full replacement of the base-course and surface is needed.

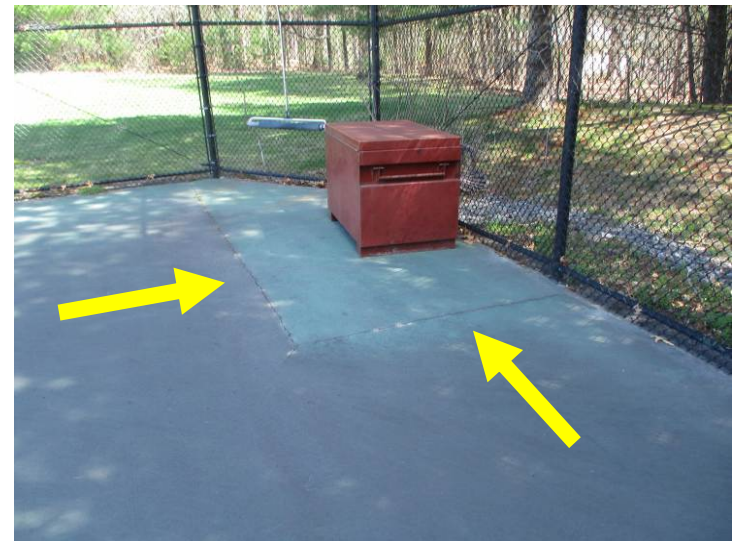
The collapsed northeast-corner was repaired, but is cracking and settling again. These issues are most likely related to the location of the courts which appears to be at a low-point of the property where drainage water migrates and settles.

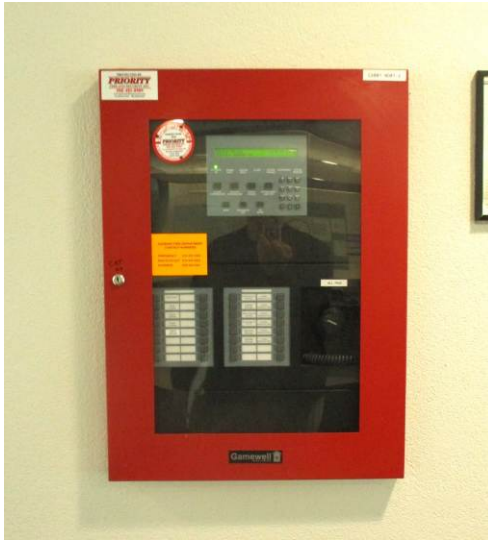
The central fire alarm system features a Gamewell addressable control panel with integrated voice-command center. Various updates have been completed over the years; however, the system is largely original (2004) and in need of replacement.

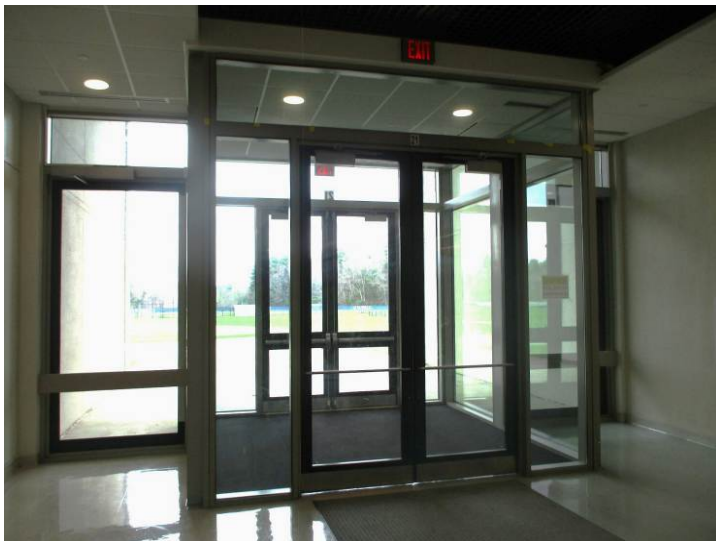
The lower (ground-floor) level of the Section C features several large, oversized, aluminum and glass doors that exhibit visible weight-related alignment issues requiring ongoing maintenance and repairs (per management).

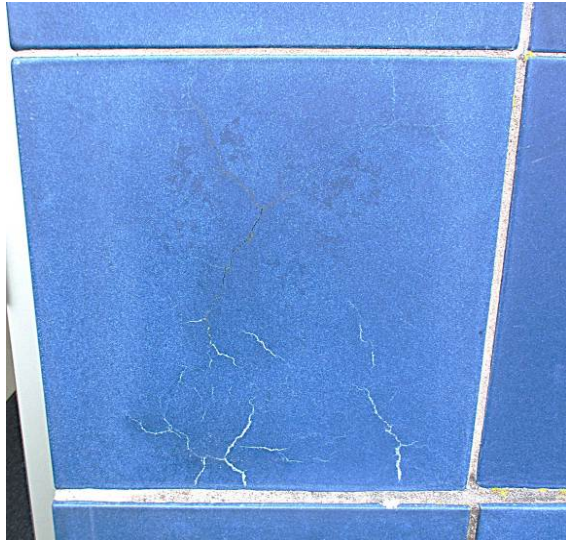
The simulated blue tile is actually a glazed masonry veneer that is developing visible age-related cracking.

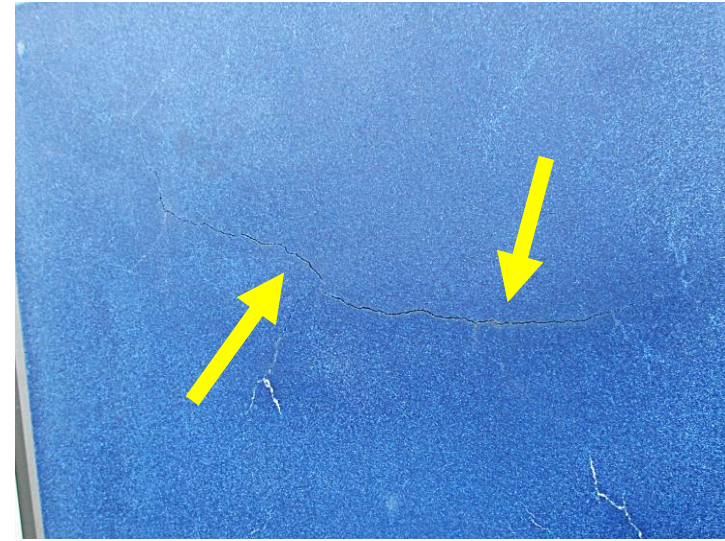
Multiple larger cracks provide an avenue for wind-driven rain and snow that can migrate behind the veneer and develop into costly water-infiltration related issues.

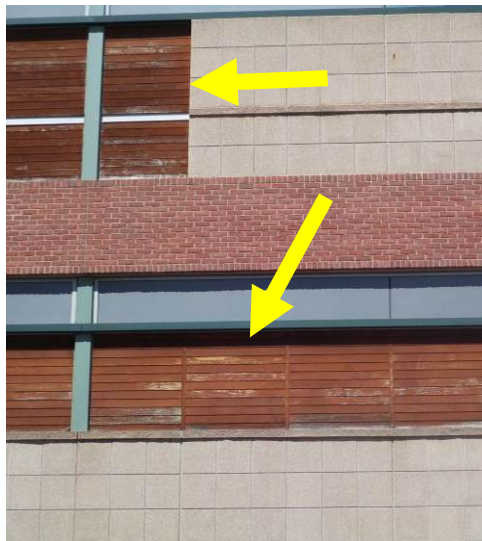
The horizontal and vertical stained-wood cladding is in need of near-term re-staining/sealing and possible eventual replacement with a more durable and low-maintenance composite-material cladding.

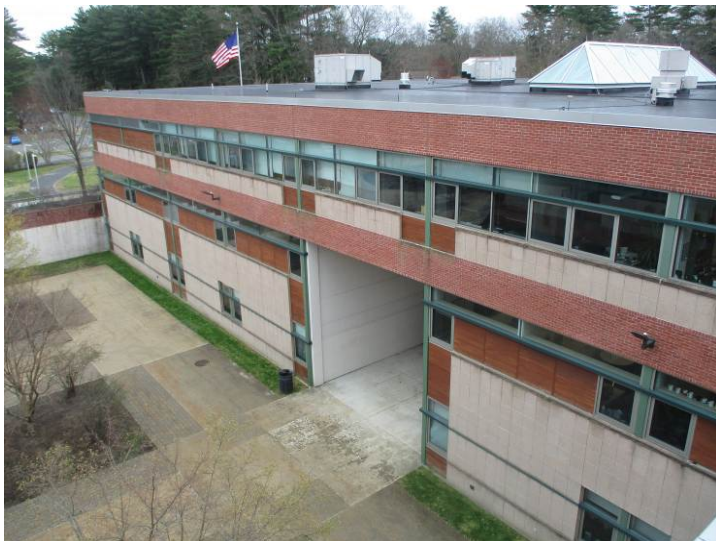
The north-facing elevation of Section A at the east-facing student entrance courtyard. The aging, deteriorating joint caulk (between dissimilar cladding materials) and the window perimeter caulk reportedly date to the original 2004 construction of the building and is in need of very near-term replacement.

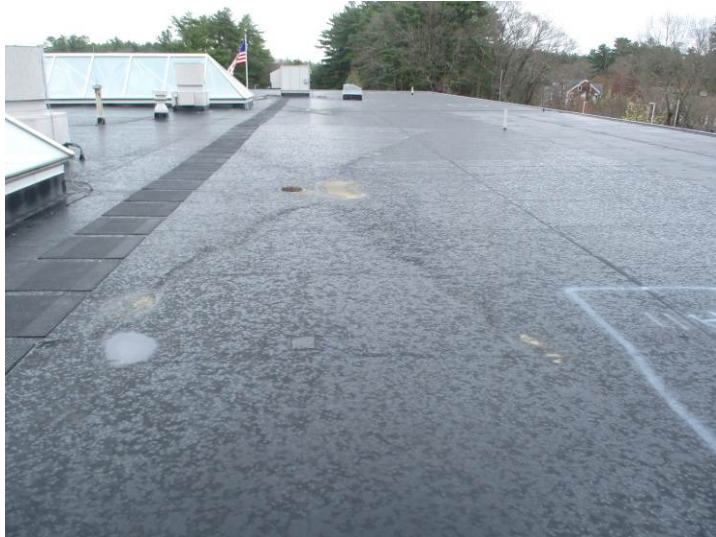
Typical single-ply EPDM membrane roof covering at all three sections. All three coverings date to the original 2004 construction and are in need of near-term replacement.

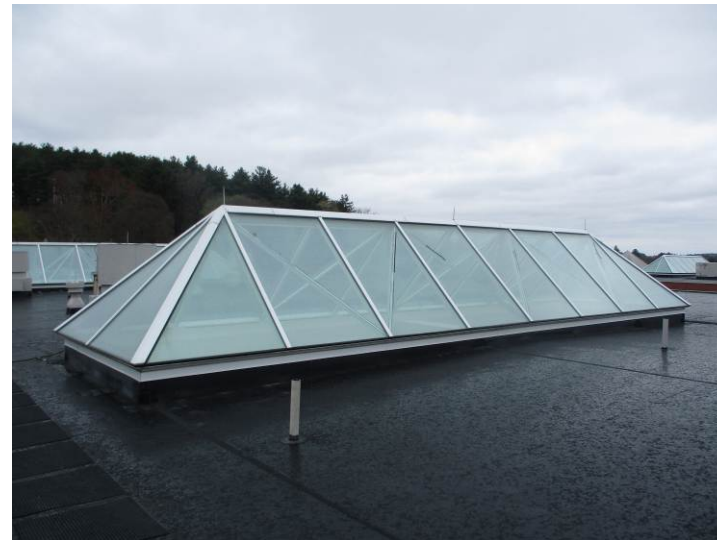
The large aluminum-framed skylight assemblies illuminating the corridors and various rooms at all three sections are reportedly in need of near-term sealing/maintenance/refurbishment.

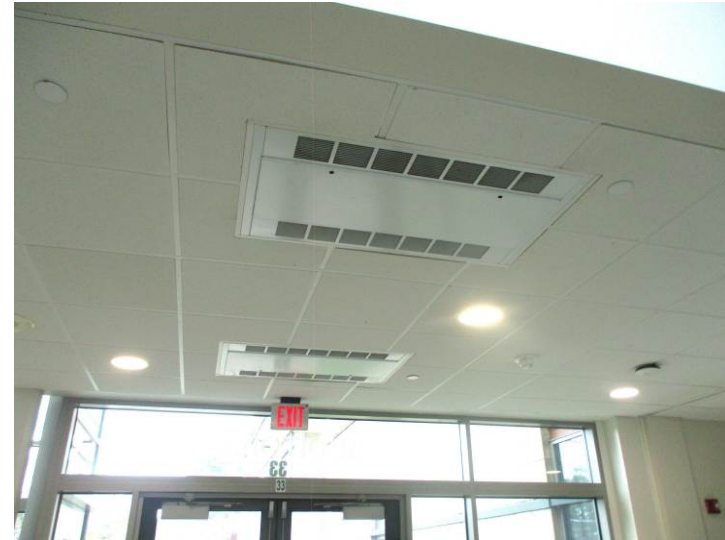
The wall-mounted and ceiling-mounted, recessed electric unit heaters that provide supplemental heat at the various upper and lower-level entrances and stairwells are all in need of near-term replacement (per management).

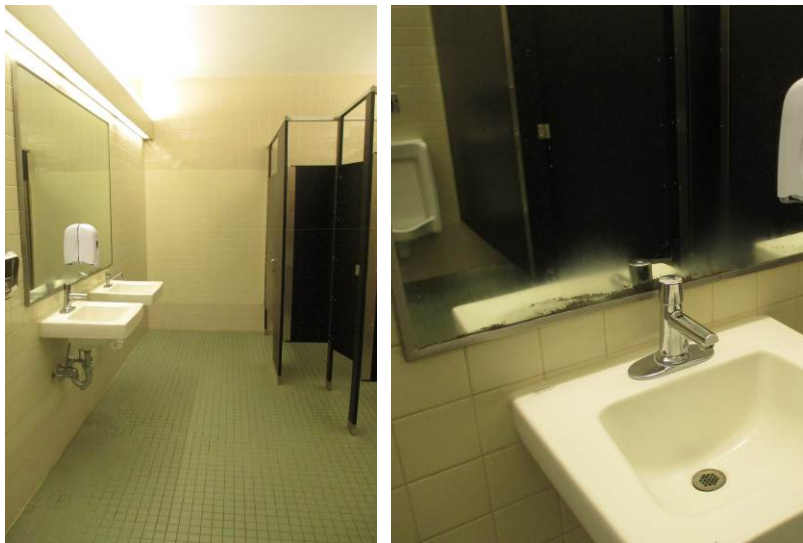
Typical finishes, fixtures, and visible age and use-related wear observed at the various boys and girls multi-stall restrooms.

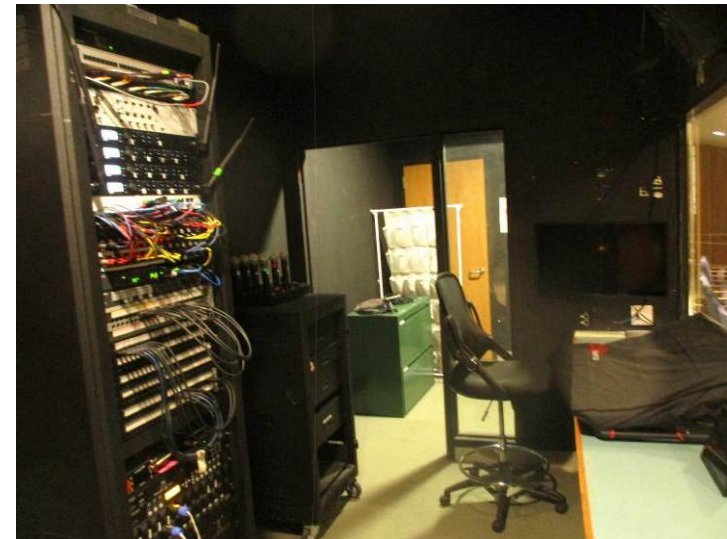
The ageing, outdated, lighting systems at the Auditorium, Black Box theatre, and Lecture Hall are all reportedly in need of a full overhaul/upgrade/replacement. The sound systems were recently updated in 2025.

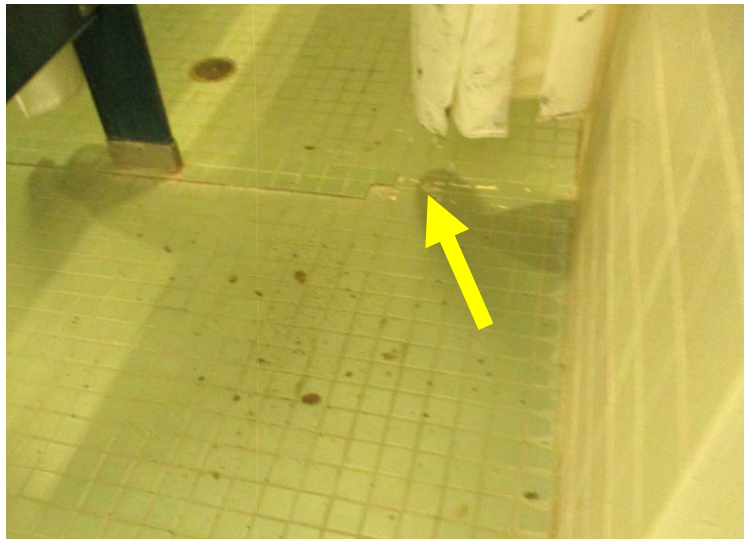
Ageing, cracked, damaged, tile flooring observed in the boys locker room shower area.

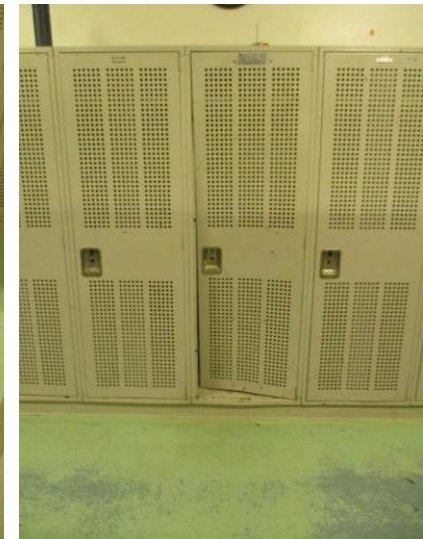
Age and hard-use related flooring wear and locker damage observed at the boys locker room.
