# PHYSICAL NEEDS ASSESSMENT

## PRELIMINARY REPORT

**Lincoln-Sudbury Regional High School**

April 30, 2026

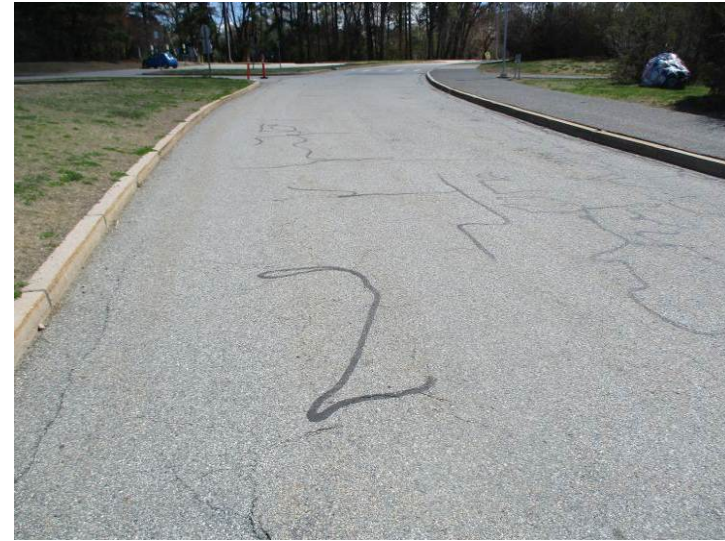
Typical roadway asphalt surface conditions.

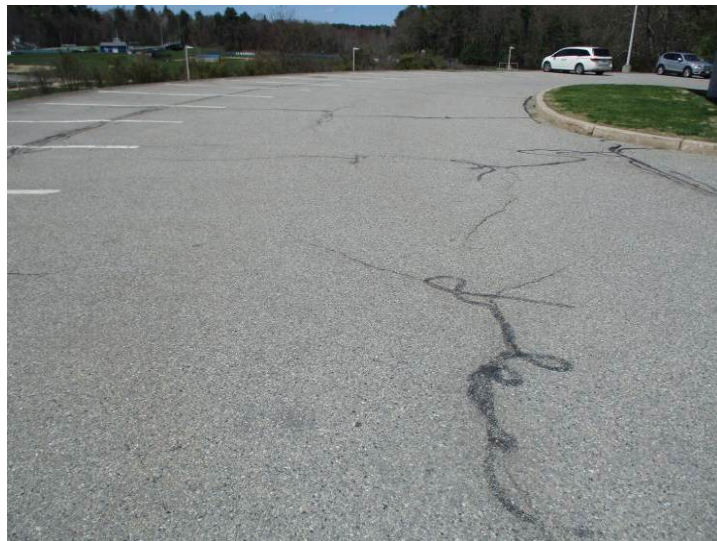
Typical drive-aisle and parking stall asphalt-surface conditions observed at the upper/main parking lot.

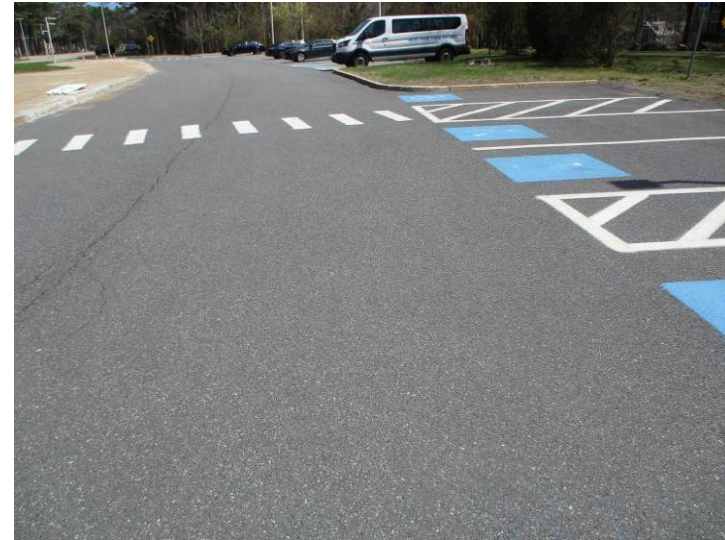
The front/main-entrance parking lot was resurfaced in 2020 and remains in good current condition.

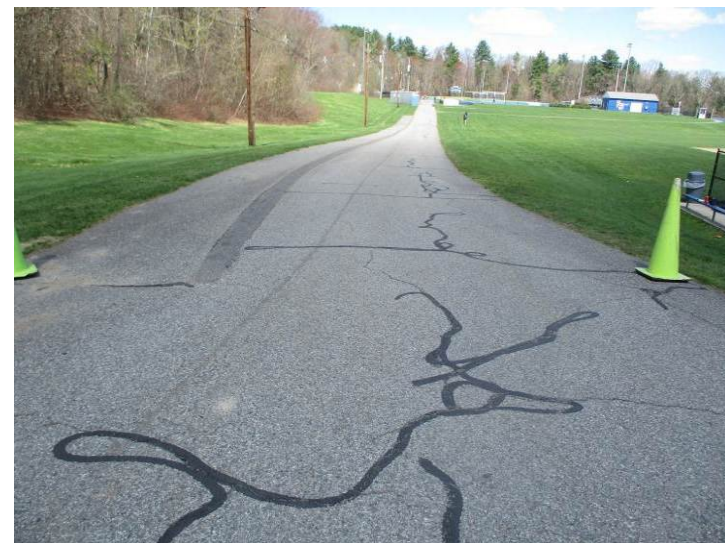
The stadium roadway and adjacent walkway conditions.

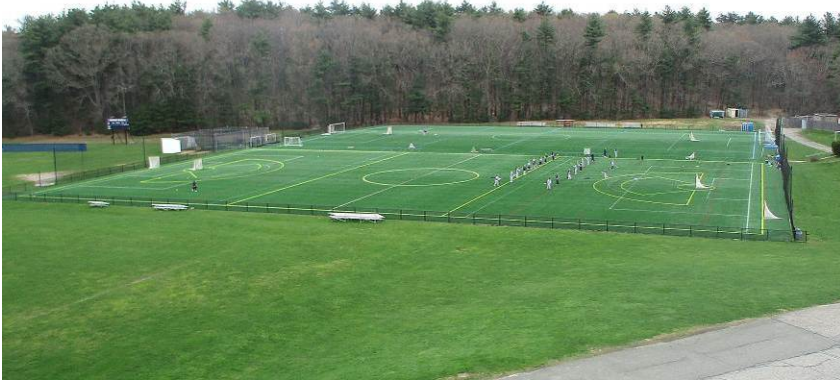
7. The artificial turf practice/playing fields (Turfs 1 and 2) were originally installed in 2006 and subsequently replaced in 2018. Future replacement cycles are shown in Years 4 and 16, after twelve years of use.

The soccer/lacrosse games fields feature artificial turf playing surfaces that were originally installed in 2006 and subsequently fully replaced in 2018.

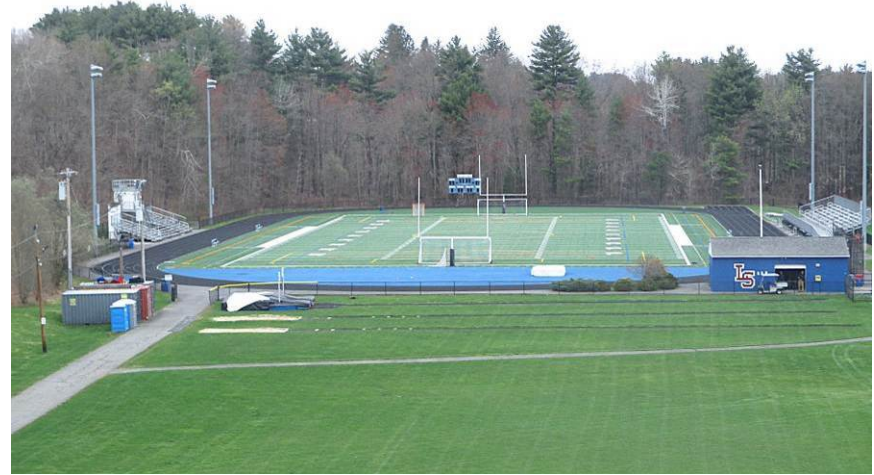
8. The artificial turf stadium field was originally in 2006 and subsequently replaced in 2021. A future replacement of this turf is shown in Year 10, after fifteen years of use.

The stadium field also features an artificial turf playing surface that was originally installed in 2006 and subsequently replaced in 2021.

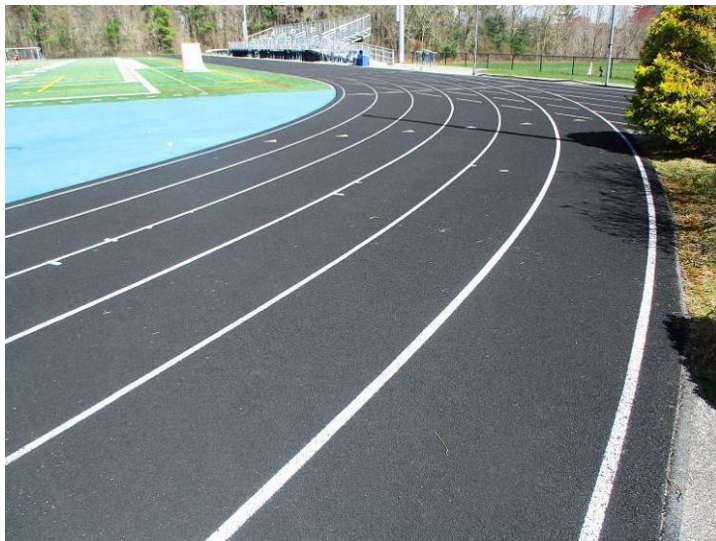
6. The Stadium features a rubberized 6-lane running track and football field D-area that was originally installed in 2007; and a subsequent structural spray resurfacing was completed in 2019. Visible cleat-related surface wear has developed since that time (particularly at the first 100 meters between the start line and first turn). Based on current age, observed conditions, and timing input from management, a full replacement of the track (base-course and surface) is shown in Year 4; and a subsequent spray resurfacing cycle is shown in Year 14, after ten years of use.

The rubberized running track and stadium field D-area were originally installed in 2007, and a subsequent structural spray resurfacing was completed in 2019.

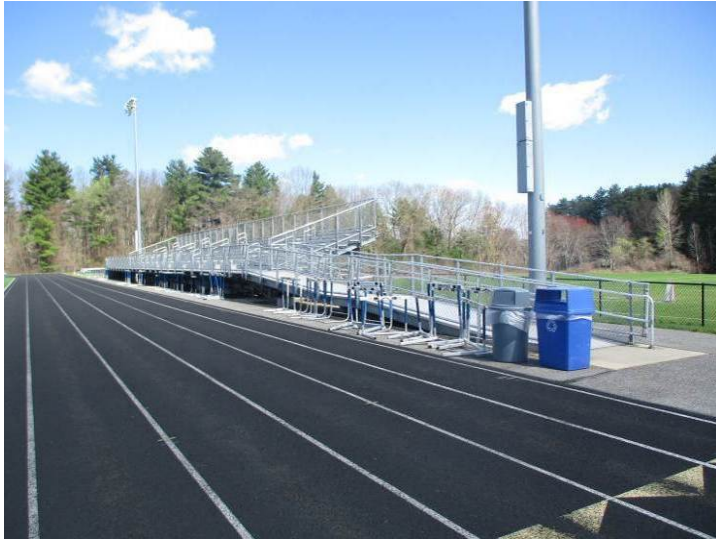
The durable steel-framed, aluminum spectator bleachers remain in good current condition.

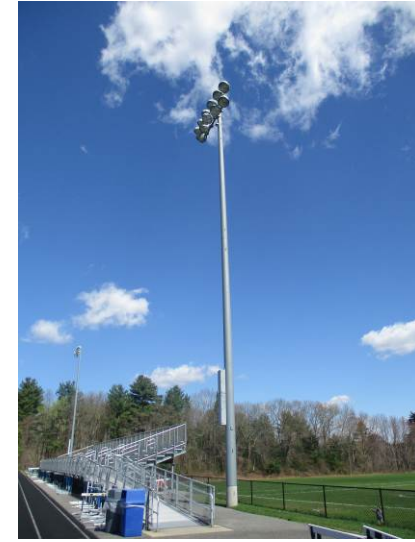
9. The Stadium lighting system (poles and fixtures) was installed in 2012, and no issues related to it were reported by management or maintenance staff during the assessment. A future replacement is shown in Year 6, after twenty years of use.

The four large sectional galvanized-steel poles (two on each side of the field) and large sodium discharge field-lighting fixtures were all newly installed in 2012.

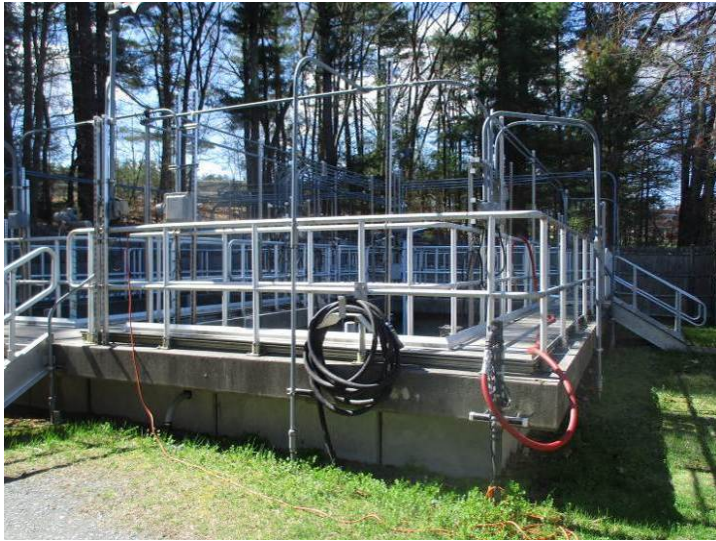
The property also features a sequencing batch reactor (SBR) style wastewater treatment facility (featuring various open/exposed and below-ground influent, reactor, mixing, aerating, and settling tanks) that was newly constructed in 2004.

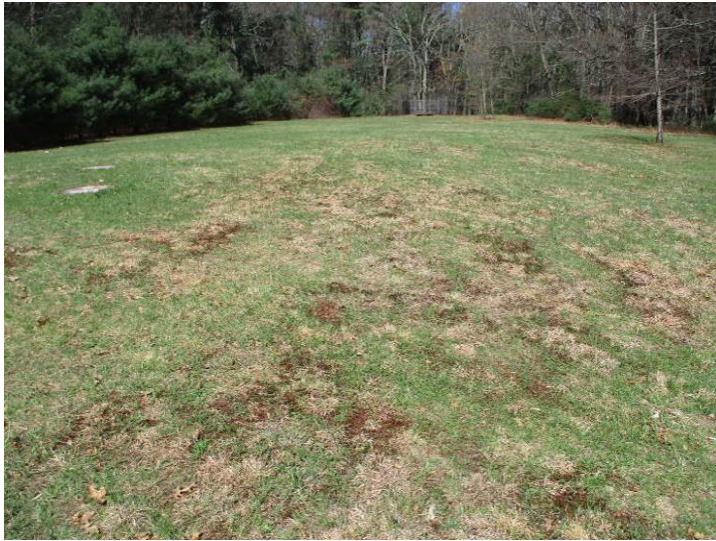
13. The clarified/treated wastewater produces very limited stress on the field which is expected to have a very long useful service life. As-such a future rebuild/replacement of the field is not expected to be necessary during the plan's timeframe.

The treated/clarified wastewater is eventually pumped up to a large, raised leaching field located above the facility at the east side of the property.

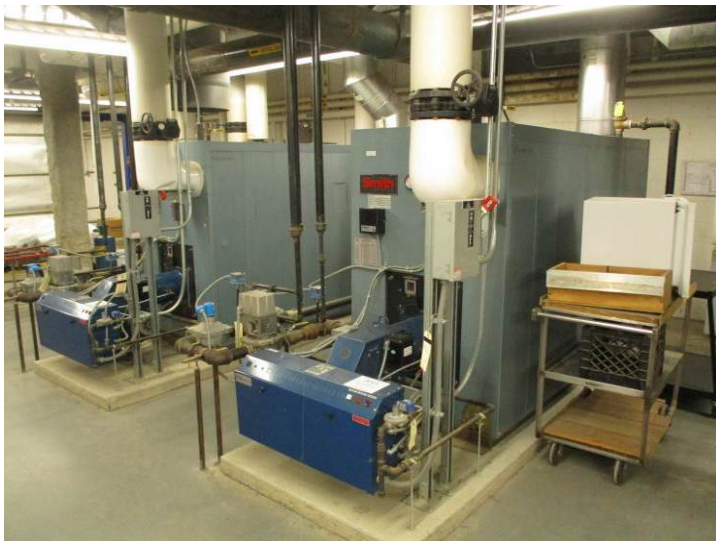
16. No operating or other issues related to visibly well-maintained heating and DHW equipment were observed or reported during the assessment. Future replacement of the boilers is shown in Year 18 (after forty years of use), and a future interim replacement of the burners is shown in Year 3, after twenty-five years of use.

The majority of the interior spaces are heated and cooled by a four-pipe water-source heat-pump HVAC system. The service optimal water temperature range (70°- 90°) is maintained by a pair of Smith Series 28A, 13-section, 2,867-mbh, natural gas-fired, commercial, cast-iron, hot-water boilers.

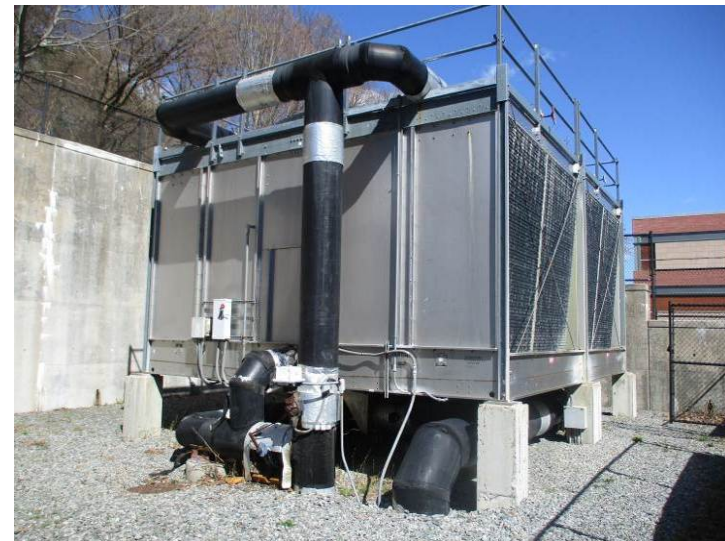
26. Heat rejection from the HVAC service-water loop is managed by an exterior pad-mounted, Marley, 900-ton, stainless-steel, dual-cell, induced-draft, cross-flow cooling tower that appears to be in very good, well-maintained condition (no operating issues reported). A future replacement of this unit is shown in Year 8, after thirty years of use.

Heat rejection from the service-water loop (to maintain the optimal 70° - 90° temperature range ) is managed by an exterior, pad-mounted, Marley, 900-ton, dual-cell, induced-draft, cross-flow cooling tower with two 20-hp fan motors.

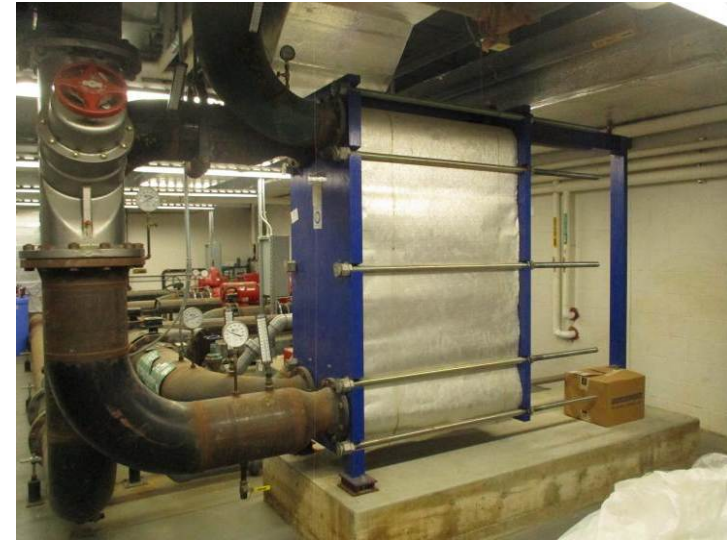
19. The shell-and-tube and plate-and-frame heat-exchanges typically see very long useful service lives if well maintained. This includes separating and cleaning the plates and replacing the gaskets as-needed at the plate-and frame unit and opening the shell-and-tube units and replacing the internal bundles. These processes (recently completed on the plate-and-frame unit) are expected to be completed from the facility's operating budget (under \$50,000 each). If performed regularly, then a future full replacement of these units is not expected to be necessary during the plan's timeframe.

A large (319 plate) Mueller plate and frame heat exchanger transfers the collected heat within the service-water “closed” loop to the condenser-water “open” loop which is then delivered to the cooling tower for release. This separation protects the water-source heat-pumps from potential contamination.

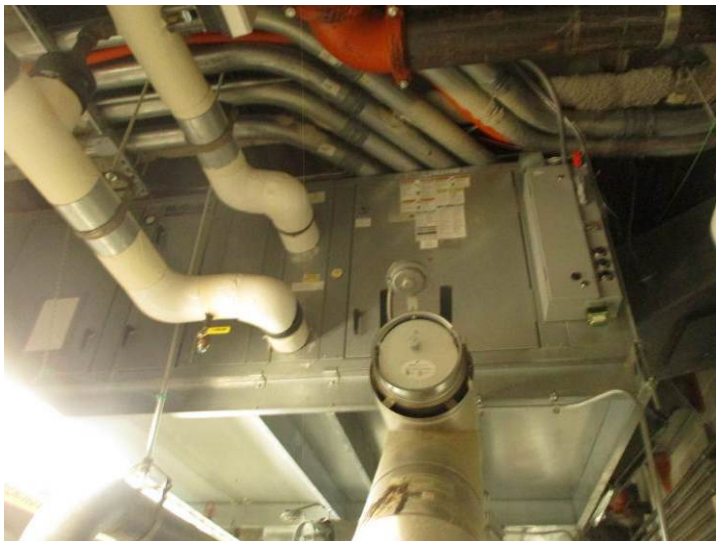
The lower-level automotive shop and the baseball batting cage room are heated and ventilated by individual ceiling-mounted, hydronic heating/ventilation units (HV-1 and HV-2) that are connected to the boiler-water loop.

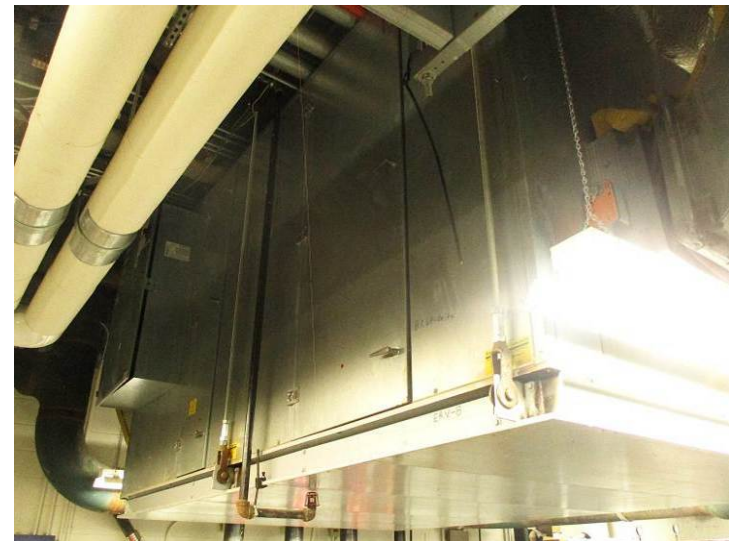
Fresh and tempered air makeup-air for the lower-level locker rooms is produced by a ceiling-mounted, McQuay, 7,200-CFM, 556-MBH, makeup air unit (located inside the boiler room).

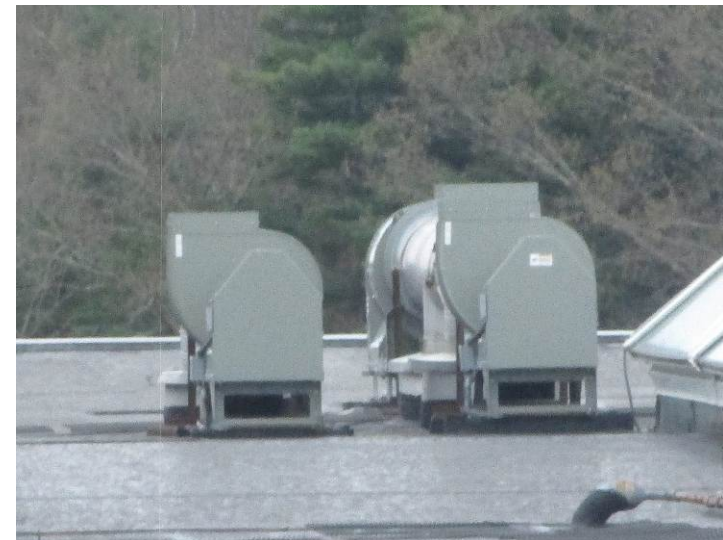
Each building section (A, B, and C) also features four large Greenheck, 20,000-cfm, up-blast smoke control fans that are controlled by the central fire alarm system.

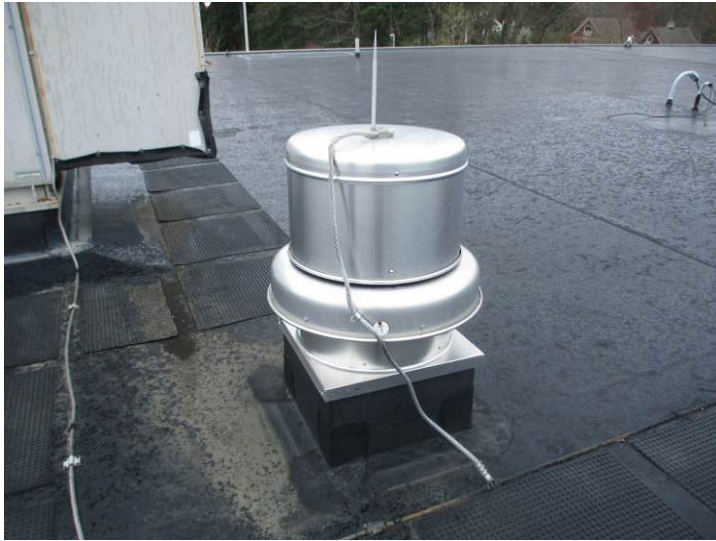
Three rooftop-mounted 2,750-cfm, 2,810-cfm, and 4,050-cfm belt-driven, upblast utility blowers produce the exhaust needs for the large commercial kitchen at the section B cafeteria.

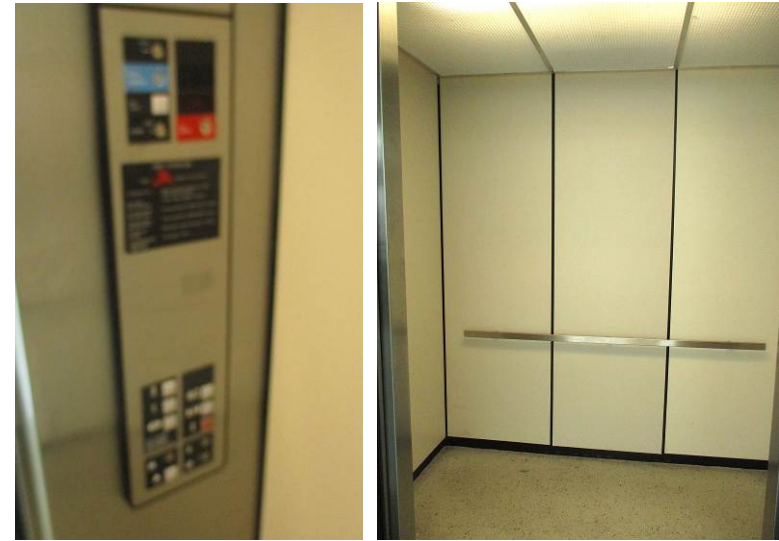
The A-section features an Otis three-stop hydraulic elevator system with 25-hp submerged-pump hydraulic power unit and wall-mounted solid-state controller

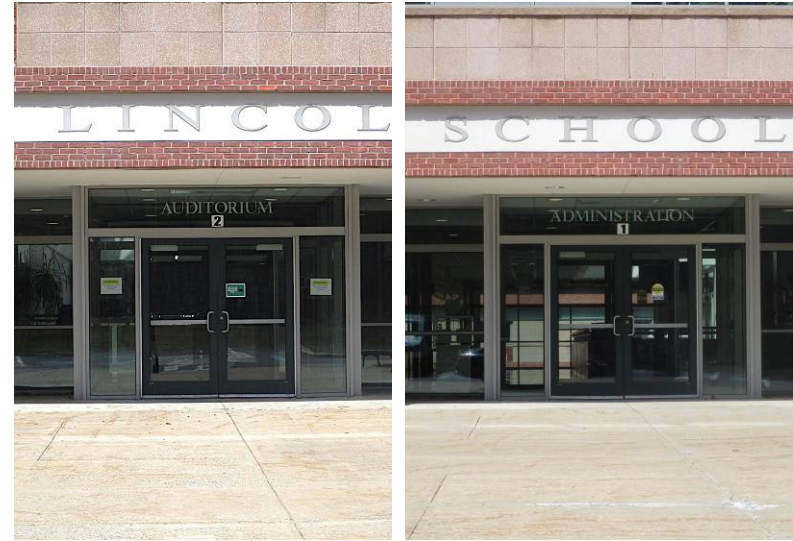
The south-facing (front) elevation of the A-section. This section features two above-grade levels, one below-grade level, and the auditorium and administration entrances.

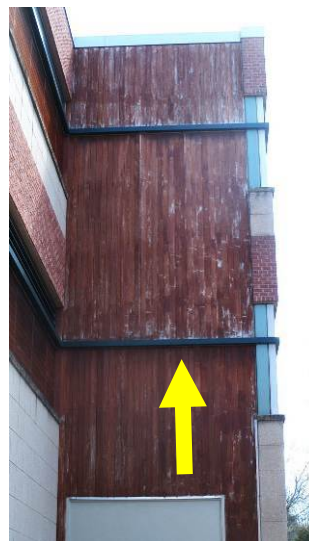
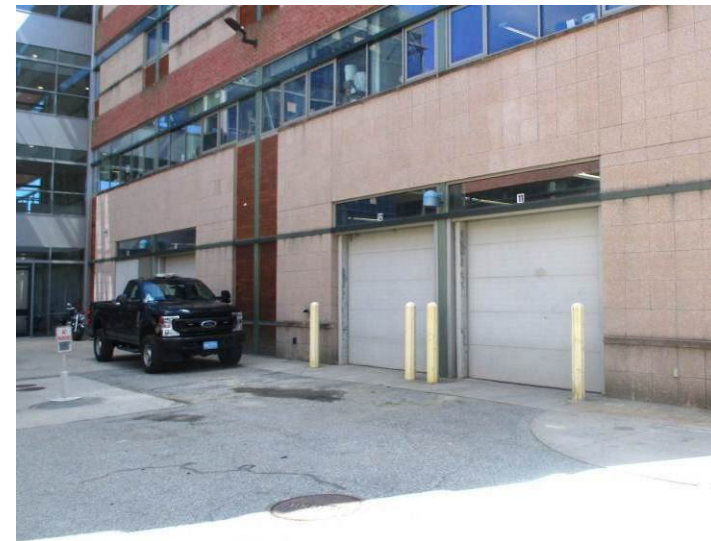
The horizontal and vertical stained-wood cladding is in need of near-term re-staining/sealing and possible eventual replacement with a more durable and low-maintenance composite-material cladding.

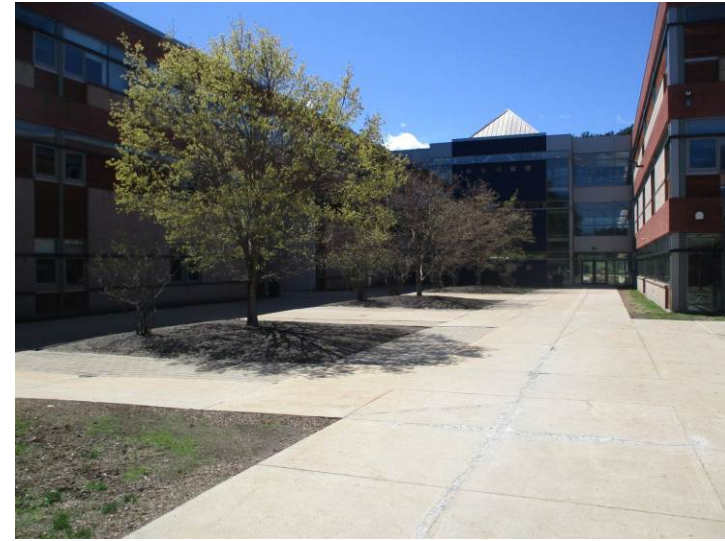
The south-facing elevation of Section C at the east-facing (rear) lower service courtyard.

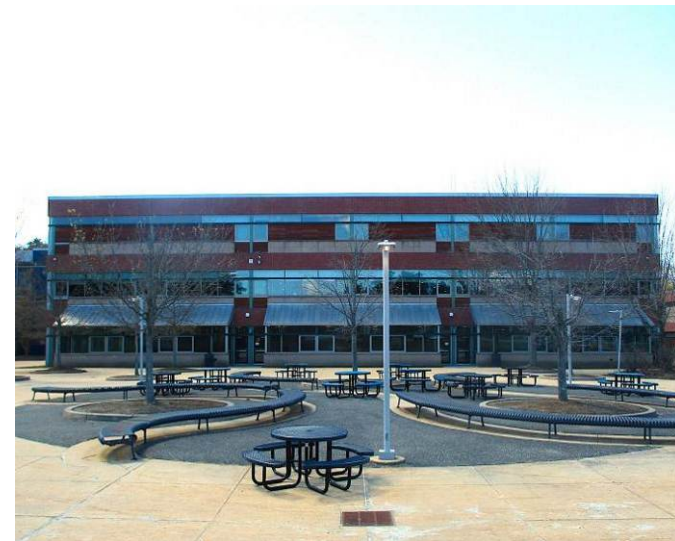
The north-facing elevation of Section A at the east-facing student entrance courtyard. The aging, deteriorating joint caulk (between dissimilar cladding materials) and the window perimeter caulk reportedly date to the original 2004 construction of the building and is in need of very near-term replacement.

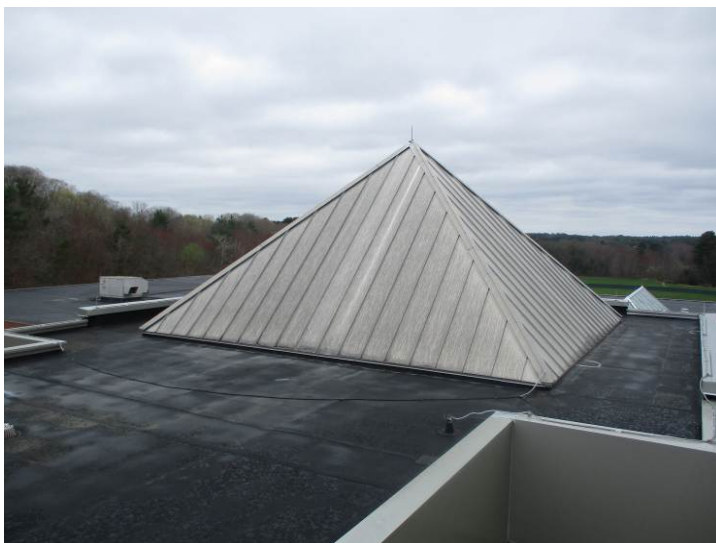
The large aluminum-framed skylight assemblies illuminating the corridors and various rooms at all three sections are reportedly in need of near-term sealing/maintenance/refurbishment.

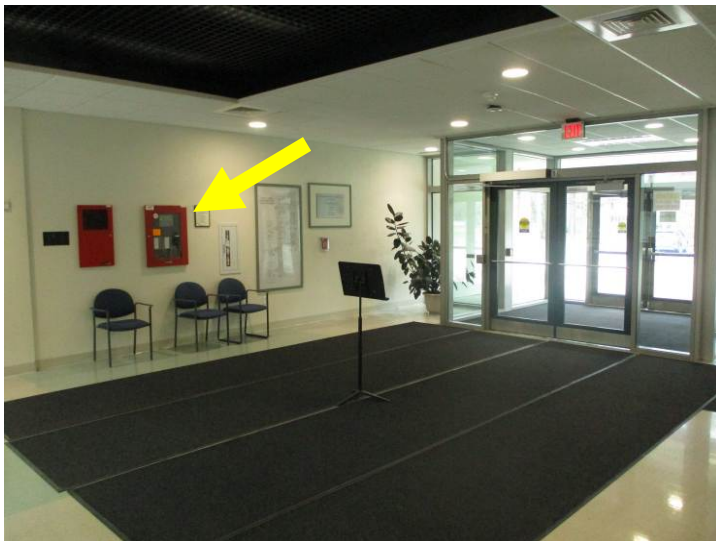
The wall-mounted and ceiling-mounted, recessed electric unit heaters that provide supplemental heat at the various upper and lower-level entrances and stairwells are all in need of near-term replacement (per management).

- 62. Various entrances and stairwells feature a mix of wall-mounted and ceiling-mounted recessed electric unit heaters that are now at or past the end of their typical useful service lives. Replacement of all fifteen units is shown in Year 1, based on current age, typical EUL, and input regarding age-related operating issues from maintenance staff.

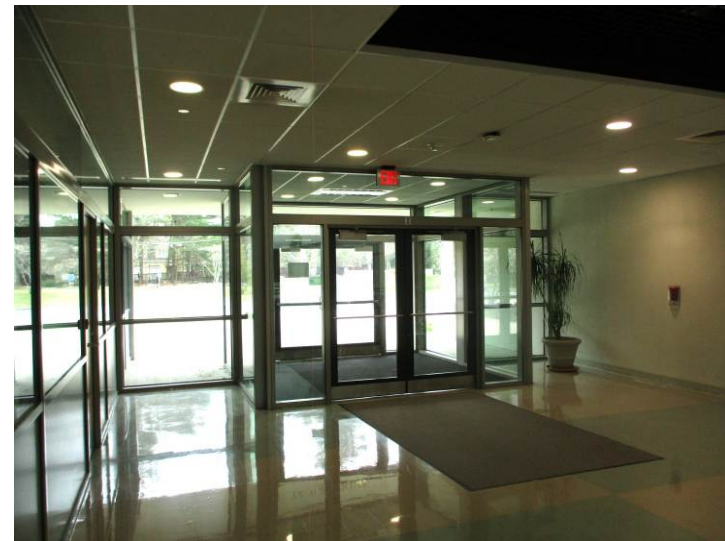
The upper-level (A section) admin entrance finishes and the central fire alarm system control panel.

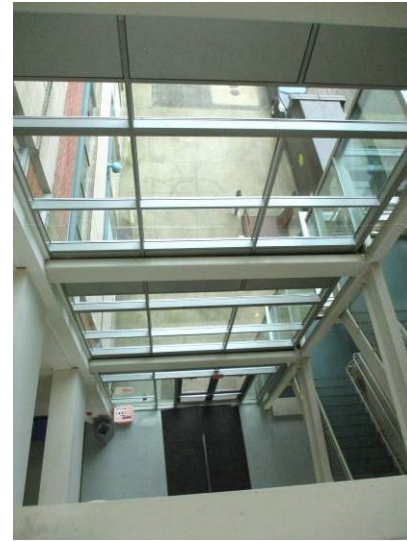
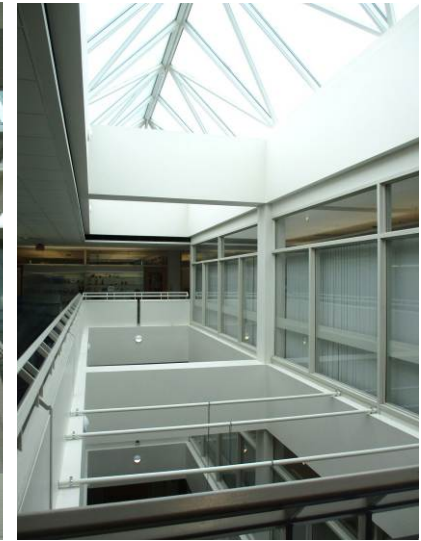
Typical steel-framed aluminum and glass curtain-wall assemblies (at the connecting corridors), and multi-level open courtyards illuminated by large aluminum and glass skylight assemblies.

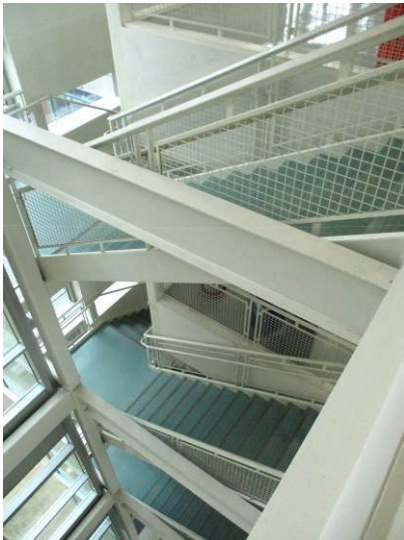
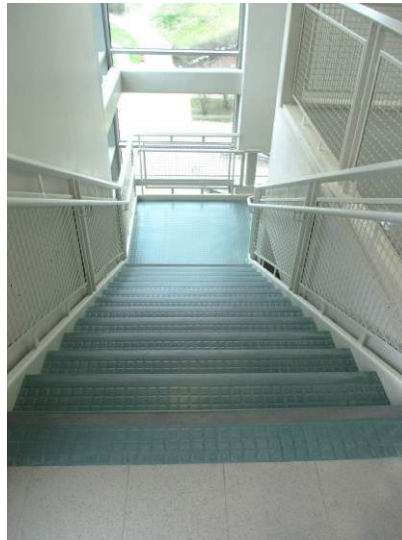
Typical finishes observed at the various open tower stairwells (above) and enclosed egress stairwells.

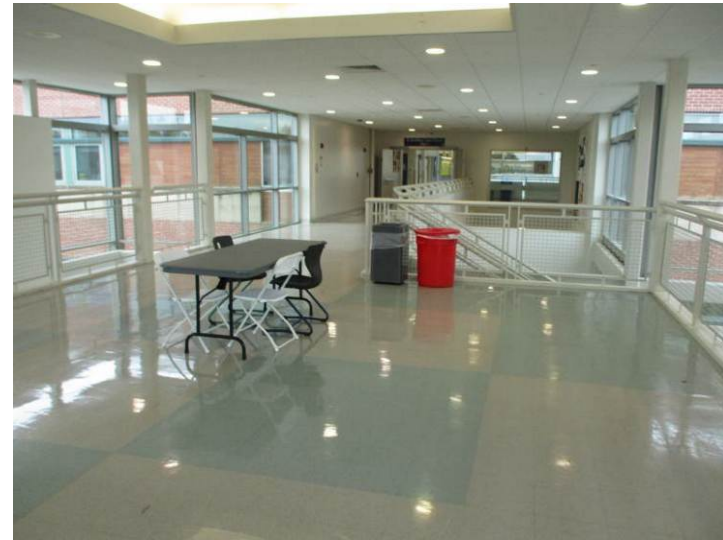
Typical connecting corridor finishes and conditions. The vinyl tile flooring is stripped and polished annually (every summer) and buffed regularly throughout the school year.

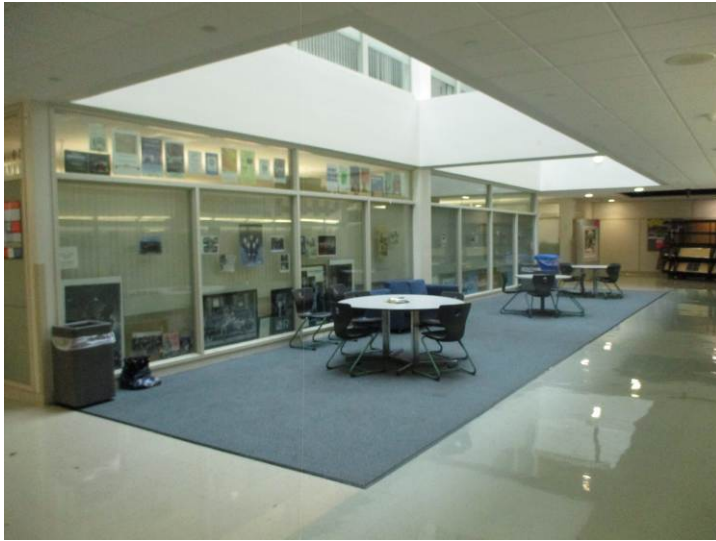
Various corridor lounge/study/gathering areas feature broadloom carpet flooring that reportedly dates to the original 2004 construction.

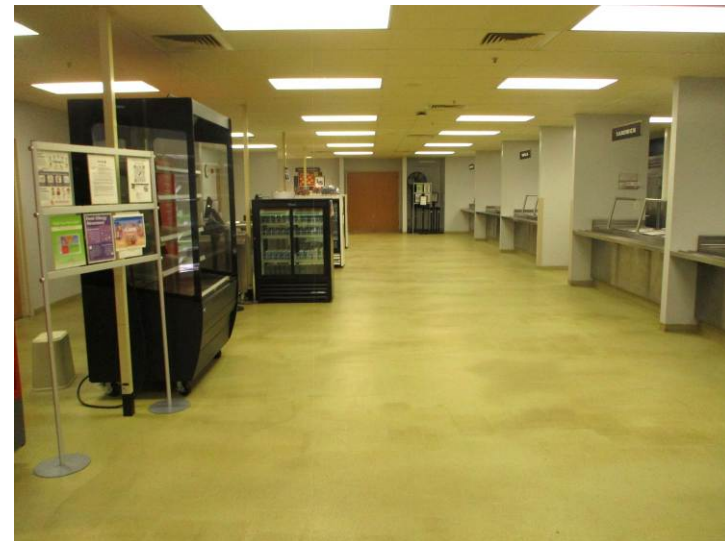
The cafeteria service area features a roller-applied epoxy-coat flooring that will be stripped down to the original concrete in the near term. The epoxy traps dirt and is difficult to keep clean.

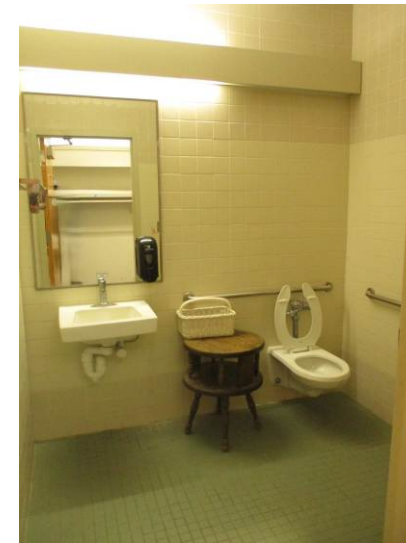
Typical finishes and fixtures at the barrier-free accessible staff and single-user restrooms.

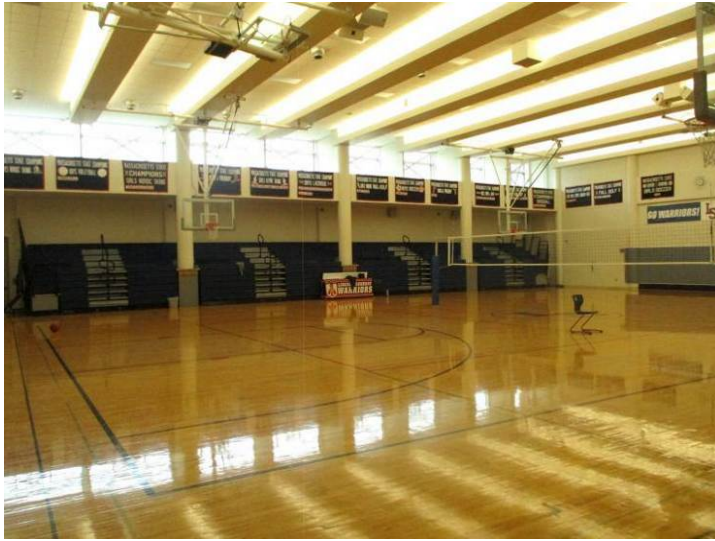
Gym 1 features a finished wood-strip flooring. A buff and coat (screen and re-coat) maintenance refinishing cycle is completed annually (per management).

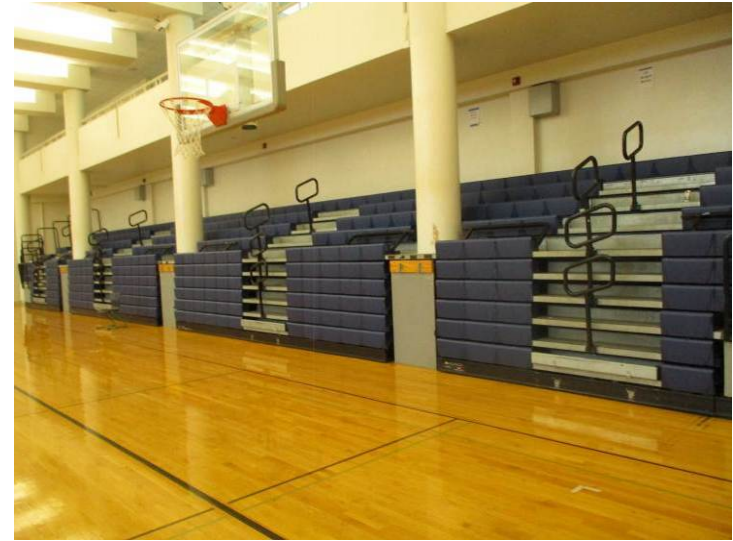
The electric (motorized/telescopic) bleachers reportedly date to the original 2004 construction but remain in generally good current condition.

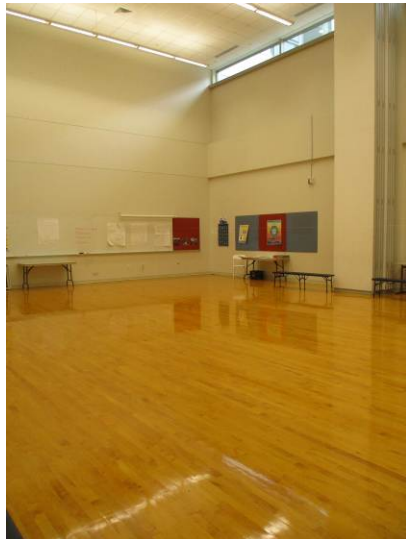
The wood-strip flooring at the Multi-Purpose Room also undergoes an annual buff and coat refinishing cycle and remains in good current condition.

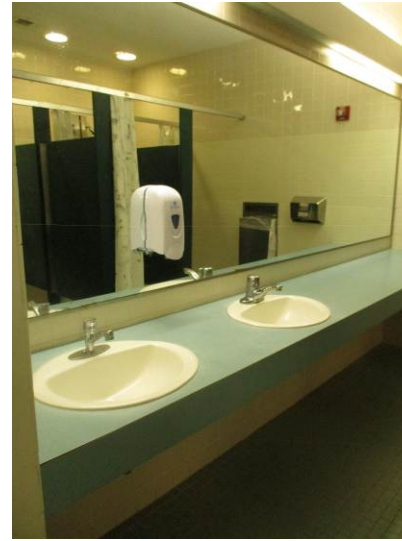
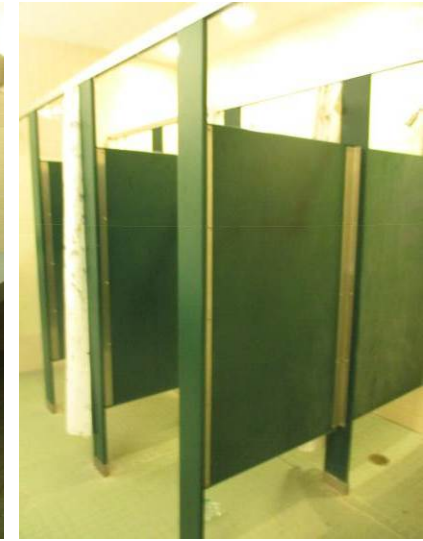
The boys locker room shower area stalls and sink counter.

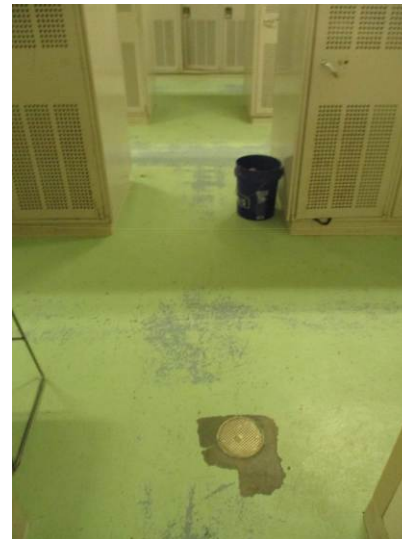
Age and hard-use related flooring wear and locker damage observed at the boys locker room.

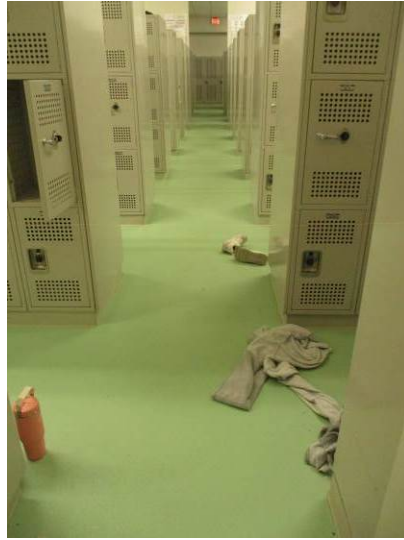
The girl's locker room sees less hard use and remains in generally good current condition.

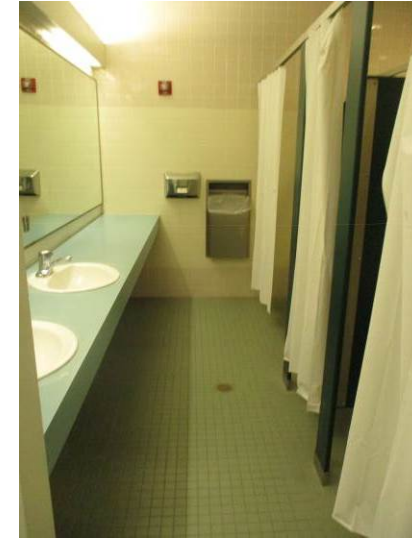
The girl's locker room shower area.

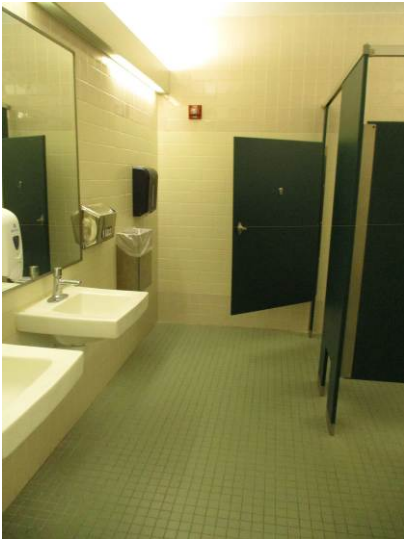
The coach's locker room also sees less hard use and remains in generally good current condition.

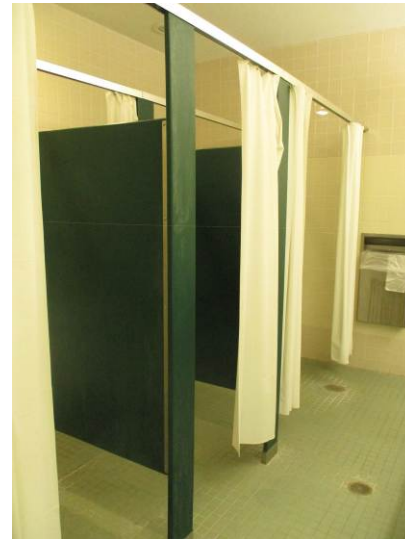
The coach's locker room shower area.

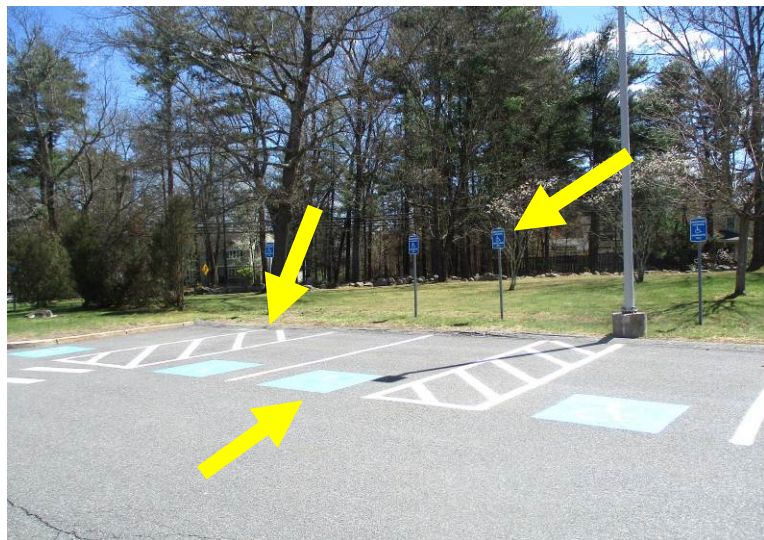
The accessible parking stalls at the front/main entrance parking lot feature compliant access-aisles, surface symbols, and standing designation signs.

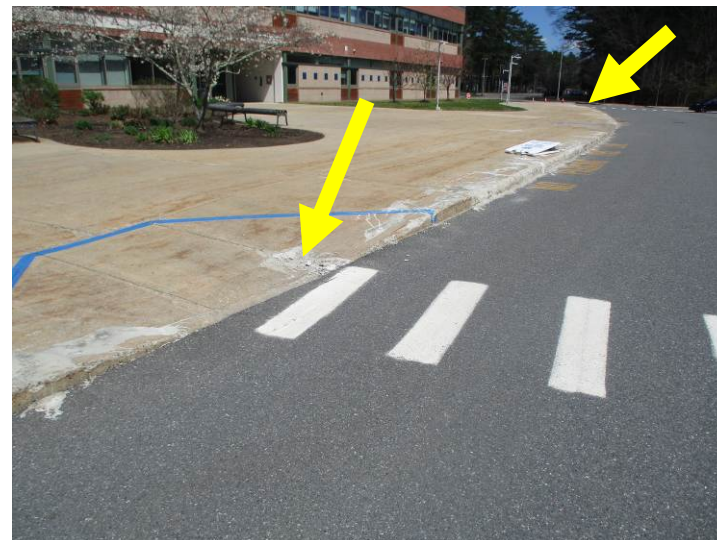
The access routes between the accessible parking stalls and the various front-elevation entrance and egress doors feature compliant curb-cuts.

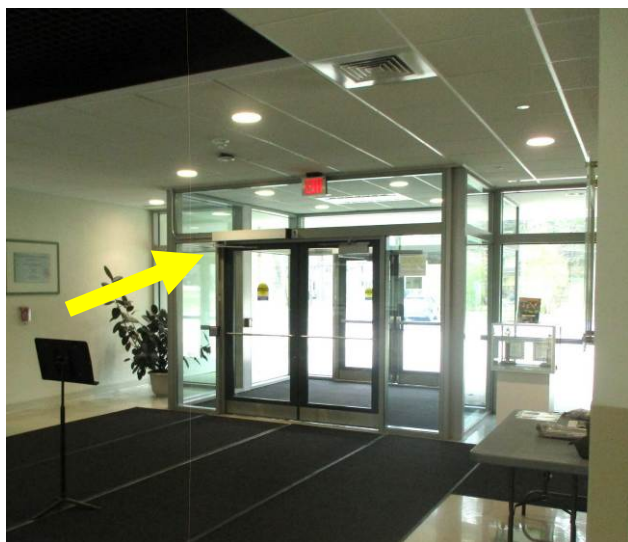
The front/main entrance vestibule features accessible power-assist openers at the exterior and interior doors.

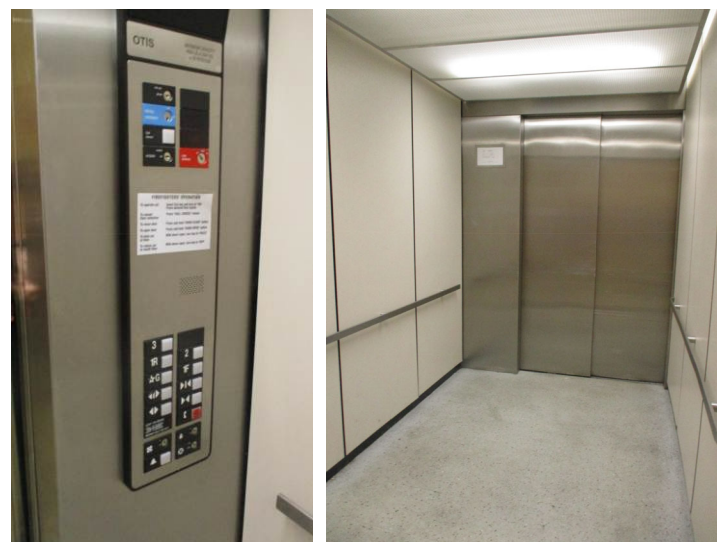
The elevator cabs feature compliant maneuvering room and door/floor buttons positioned at compliant height.

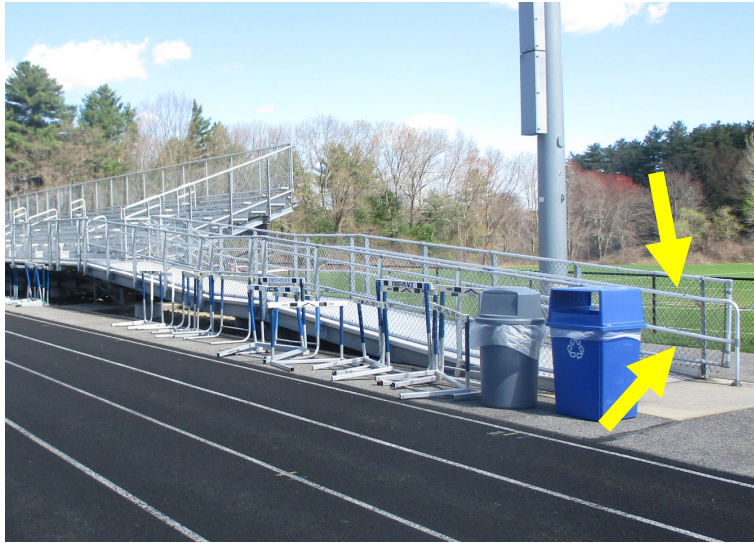
The stadium bleachers feature a compliant access ramp with dual-height continuous (uninterrupted) handrails.

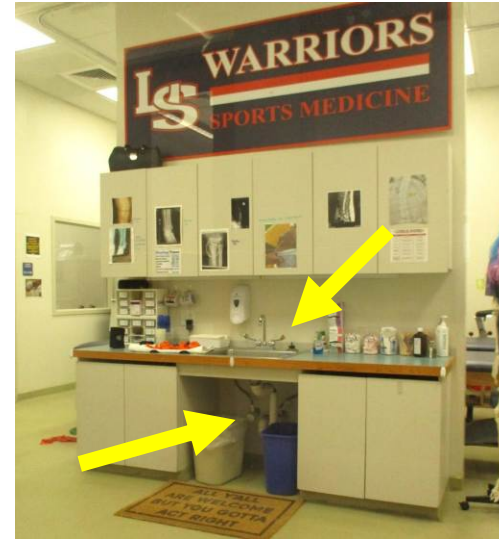
The Sports Medicine room cabinetry features a compliant roll-under sink with covered under-sink piping (to protect against potential roll-under knee-impact injury) and a compliant lever-style faucet.

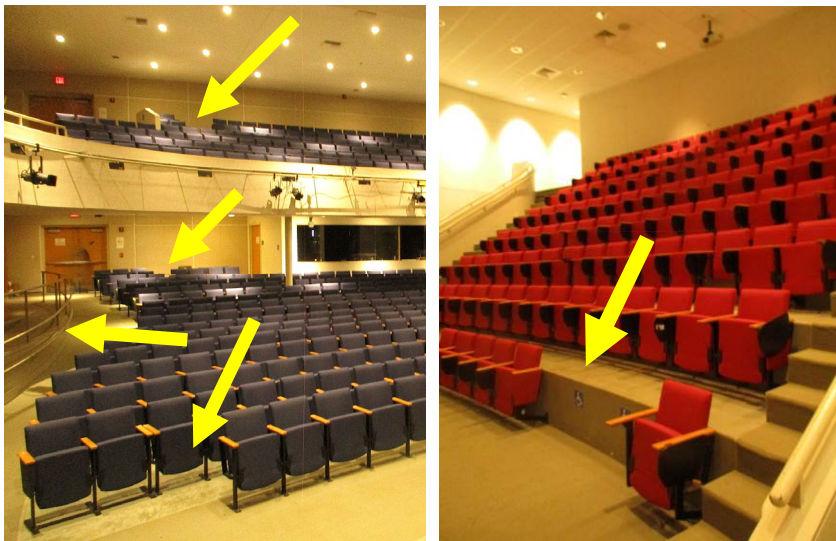
The auditorium and lecture hall feature compliant wheelchair spaces at both levels; and access routes and ramps to those spaces with compliant dual-height continuous handrails.

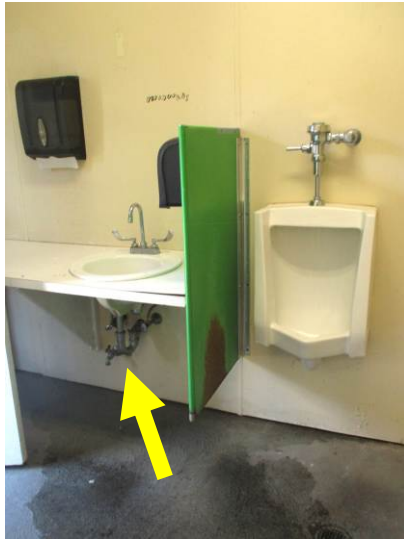
The men's and women's fieldhouse restroom sinks lack compliant piping insulation; and the men's room urinal needs to be lowered to compliant height. The rim should be positioned no higher than 17-inches above the floor.

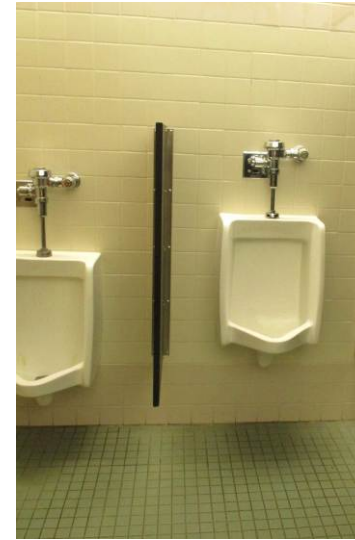
The multi-stall restrooms feature one standard-height urinal and one accessible-height urinal (which is ADA acceptable).

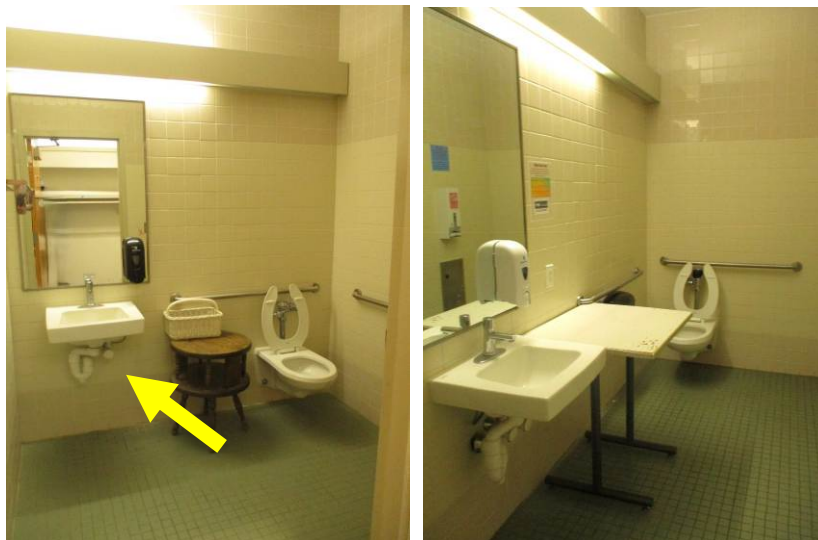
The barrier-free accessible hallway and locker-room single-user restrooms feature compliant sink and mirror heights; toilet and grab-bar positioning; and covered/insulated under-sink piping.

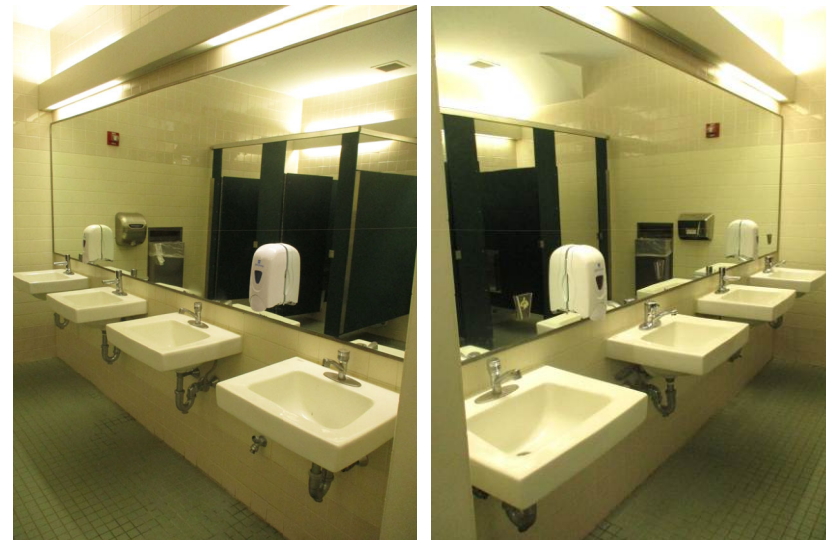
The toilet-area sinks at the boy's locker-room (left) and girl's locker room (right) all have exposed/uncovered piping.

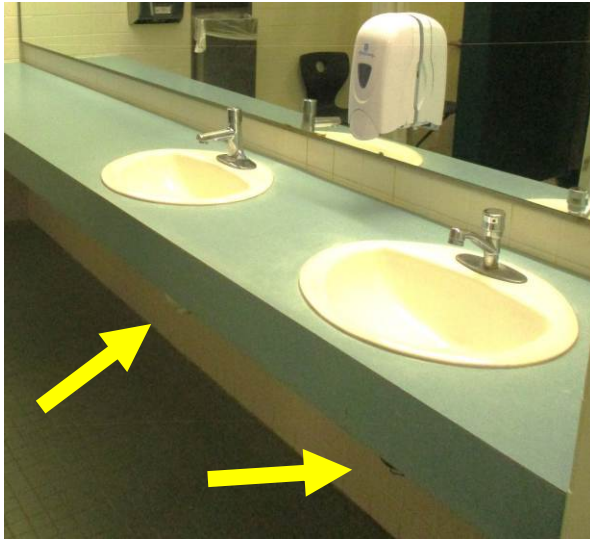
One sink at the shower-area sink-counters has covered piping, the other does not.

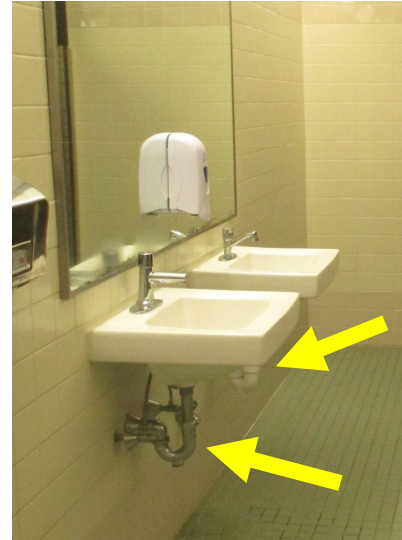
A similar issue exists at the multi-stall hallway restrooms. One sink features covered piping, the other does not.

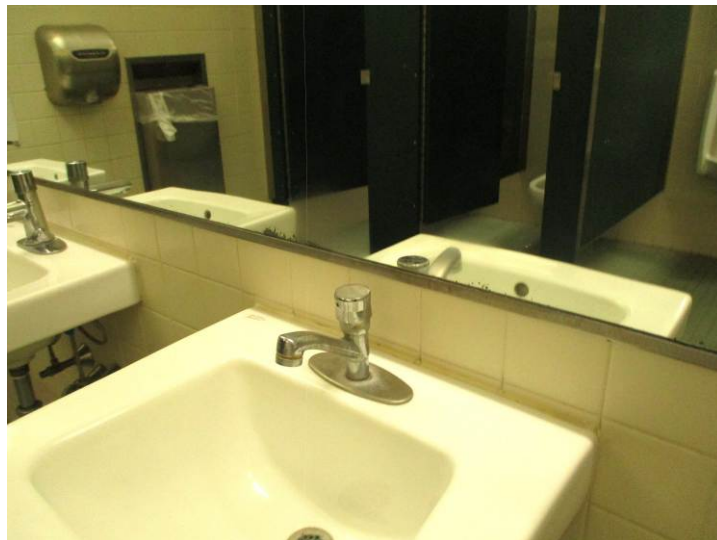
All single-user and multi-stall restroom and locker-room sinks feature push-style faucets which is ADA acceptable.
