# PHYSICAL NEEDS ASSESSMENT

## PRELIMINARY REPORT

**Lincoln-Sudbury Regional High School**

April 30, 2026

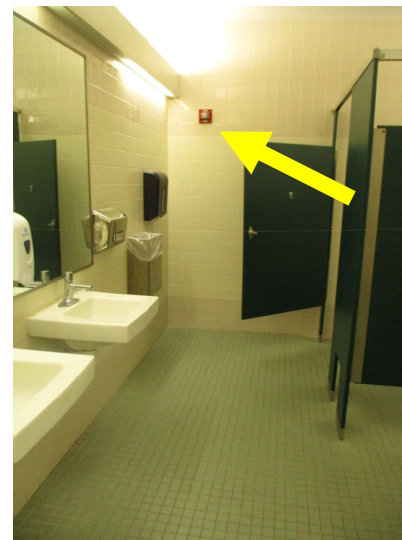
All restrooms and locker-rooms feature compliant audio-visual horn/strobe fire alarm warning devices.
